DEPARTMENT OF TRANSPORTATION**DIVISION OF ENGINEERING SERVICES**

Quality Assurance and Source Inspection

Contract #: 04-0120F4Cty: SF/ALA Rte: 80 PM: 13.2/13.9File #: 1.28**WELDING INSPECTION REPORT****Resident Engineer:**Pursell, Gary**Address:** 333 Burma Road**City:** Oakland, CA 94607**Report No:** WIR-016245**Date Inspected:** 16-Aug-2010**Project Name:** SAS Superstructure**OSM Arrival Time:** 1000**Prime Contractor:** American Bridge/Fluor Enterprises, a JV**OSM Departure Time:** 1830**Contractor:** American Bridge/Fluor Enterprises, a JV**Location:** Job Site

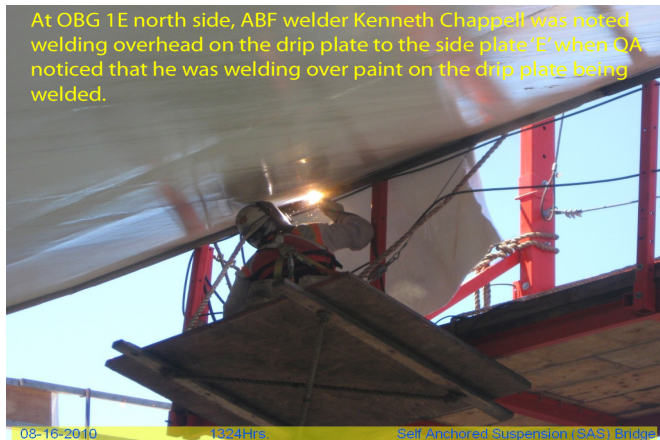
At the side plate 'E' of OBG 1E outside, ABF welder Kenneth Chappell was observed welding the 2 1/4" wide x 3/8" thick drip plate to the side plate 'E'. The welder was noted welding in the overhead position and was using 1/8" diameter, E7018H4R electrode. Prior to the observation of the welder, QA talked to the ABF QC Jim Cunningham and informed QA that the welding being done has no welding detail at hand but was told by the superintendent that the joint will be a Partial Joint Penetration (PJP) due to the natural configuration of the joint being welded. While QA was at the platform, the welder continued welding overhead using 1/8" diameter E7018H4R electrode. During the observation, it was noticed that the drip plate being welded to the side plate was painted and the paint was not ground before tack welding to the side plate and also during welding.

At OBG 1E north side, ABF welder Kenneth Chappell was noted welding overhead on the drip plate to the side plate 'E' when QA noticed that he was welding over paint on the drip plate being welded.
